Manhole Inspection Summary

Manhole # S01EE2006MH

Insp Date: **10/25/06 2:37 PM**

Location Address: **6220 BENHURST RD**

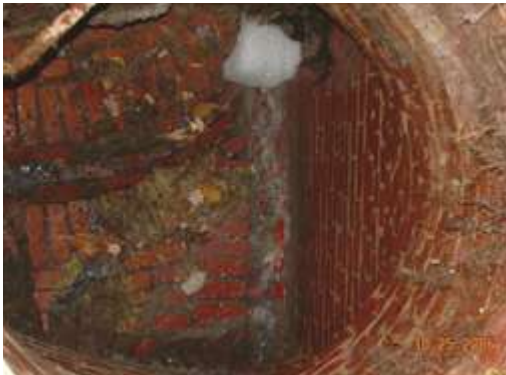
Top View

Adjustment, Corbel and Barrel root intrusion and infiltration. Corroded steps. Evidence of surcharge Bench debris.

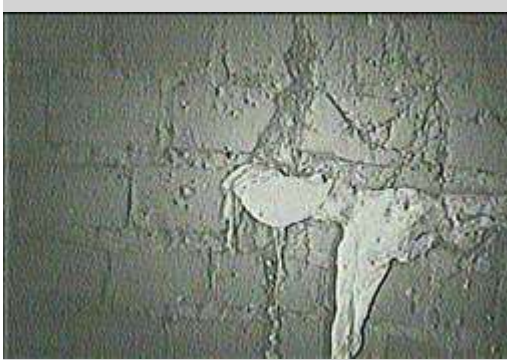
Evidence of surcharge

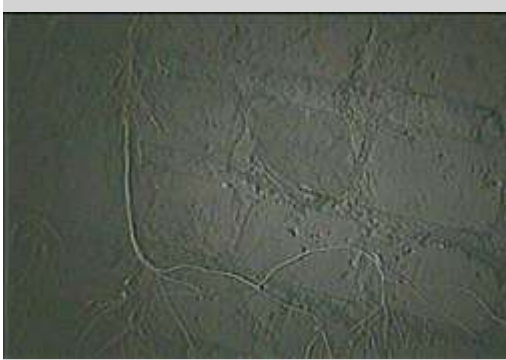
Defect

Corbel and Barrel root intrusion and infiltration.

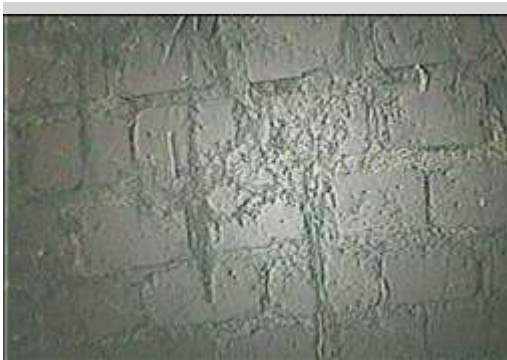
Defect

Corbel root intrusion and infiltration.

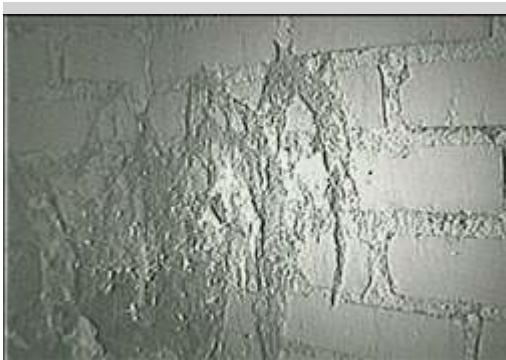
Defect

Barrel root intrusion and infiltration.

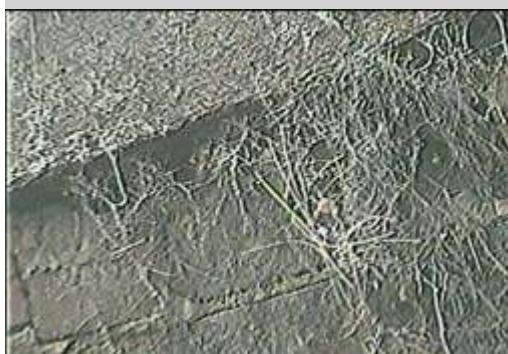
Defect

Adjustment root intrusion and infiltration.

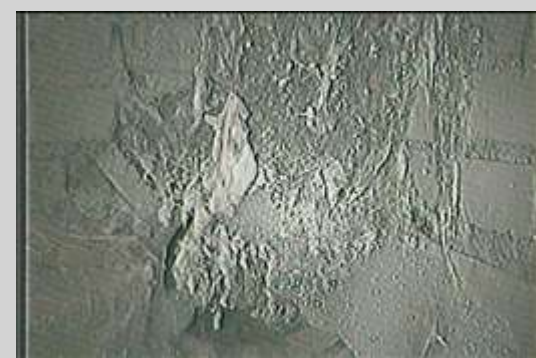
8 in. Circular Gravity Sewer Pipe Out @ 12 O'Clock

Infiltration: **Evidence** Pipe Seal Cond: **Roots**

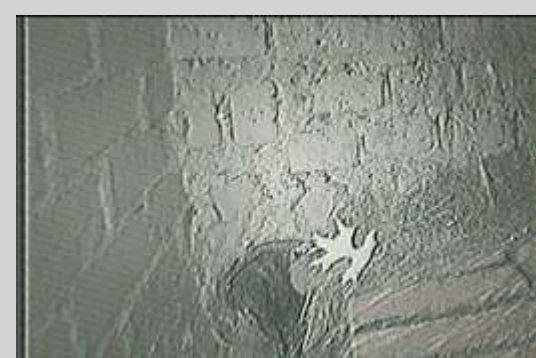
8 in. Circular Gravity Sewer Pipe In @ 6 O'Clock

Barrel deterioration, root intrusion and infiltration.

Infiltration: **Evidence** Pipe Seal Cond: **Roots**

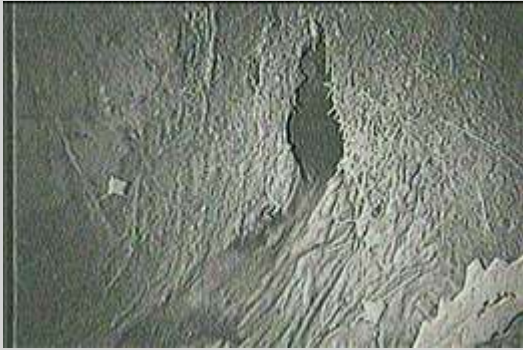
6 in. Circular Gravity Sewer

Pipe Seal Cond: **Roots**

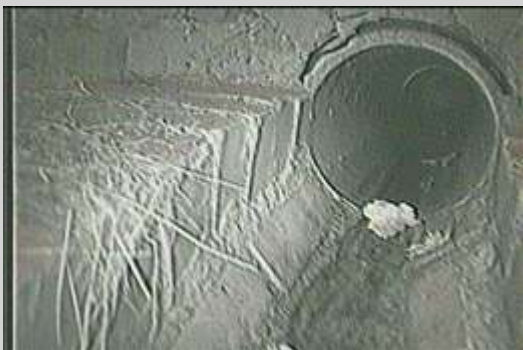
8 in. Circular Gravity Sewer

Bench root intrusion.

Infiltration: **Evidence**
